NARRATIVE INSPECTION REPORT DOCUMENT

Date	of In	spection	n:		3/2	28/9	90				 Inspecto	or:	JAMES	HAE	NNICKE	-
Site	Code:	0 3	1	6	0	0	0	0	3	4	County:		соок			
Site	Name:	LANI	3 C	LAI	KES	#3	•						T	ime:	7:20-8:30	a.m.

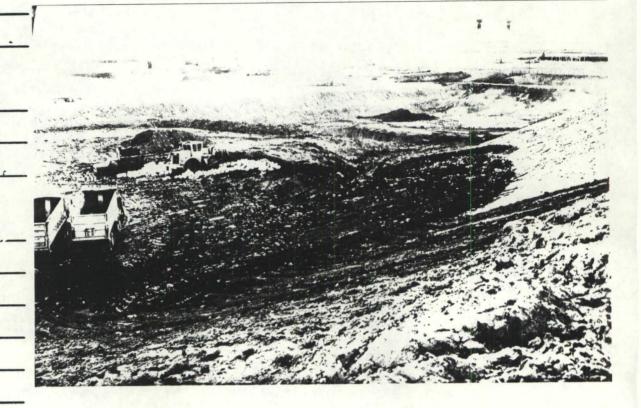
to # 1 Roll #, 90-293

- LINE 5 Due to dry on-site roads, dust caused a notable problem as seen in photos 1 & 3. Mark stated that their water truck was inoperable and currently in the on-site maintenance shop.
- LINE 26 Photo 6 depicts a small stream of leachate emanating from the road in the filled western portion of Land & Lakes. Mark asked if covering the area with clay, as in past practices, would be sufficient. I reminded him that this would only be a temporary solution. My suggestion was to include a leachate collecting concrete culvert in addition to the clay. When asked if the leachate pumped from the culvert could be deposited with the daily refuse in the active area I told Mark to transfer it instead to their wastewater pond. Here it could be permanently treated so as not to pose any problems in the future.

nments:__EAST

ACTIVE AREA; DUST

I met with Bob and Mark at 9:00 a.m. on 3/30/90, for a follow-up inspection. The leachate problem was remedied by the above mentioned actions. Also, in regard to their dust violation, Land & Lakes 3 has on site a spare water truck from their maintenance garage on 134th street.

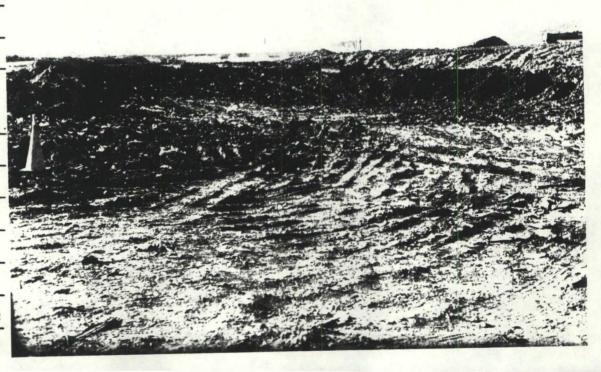
to = 2 Roll = 90-293

ments:__SOUTH

INCLEMENT WEATHER

ACTIVE AREA

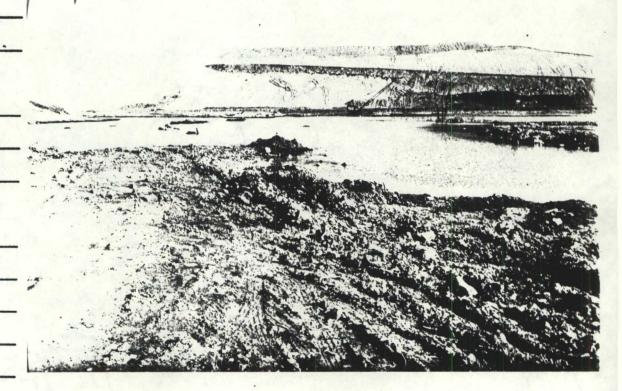
hoto # 5 Roll #, 90-293

omments: NORTH

POOLED RAIN WATER
